## MICROCLIMATIC CHALLENGES IN THE CONSERVATION OF WOODEN SACRAL MONUMENTS OF CULTURAL HERITAGE: A CASE STUDY OF A WOODEN CHURCH IN RĂSTOLȚU DEȘERT (ROMANIA)

Received: February 5, 2025 | Revised: March 20, 2025 | Accepted: April 2, 2025  
Paper No. 25-67/1-747

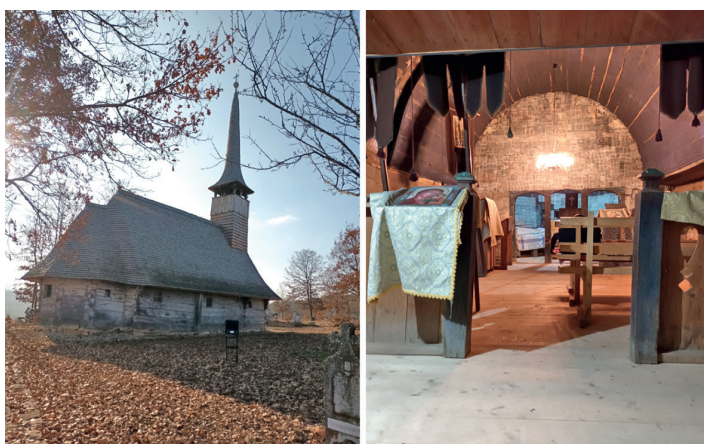
**Fig. 2** The wooden church is a historical monument in the locality of Răstolțu Deșert

The object of research is a wooden sacral building—the wooden Church of the Assumption of the Virgin Mary in Răstolțu Deșert (Romania; Figures 1 & 2). The heritage object under research represents an authentic part of the culture of the local community. It is not only used by the local community as an important local centre of social life but also serves visitors who regularly attend local sacred and secular events. The church dates from the early 19th century (Ministry of Culture, 2015). Notable for its high tower, it was built on a rectangular plan with a detached, polygonal apse with five sides (Godea et al., 1978). The church was small and in

1846, to enlarge it, a bay was added to the nave and the altar was moved to the east (Godea et al., 1978; Măruțoiu et al., 2017). On the south side, the nave was closed, creating the deaconry (Godea et al., 1978; Măruțoiu et al., 2017). The painting dates from 1810 and, according to Măruțoiu, was made by Ioan Pop from Românași, where we find the Passion of Christ, the Last Supper, St. Elijah with the Chariot, the Parable of the 10 Virgins and Figures of Myrrh-bearers (Godea et al., 1978; Măruțoiu et al., 2017). The Church of the Assumption of the Virgin Mary in Răstolțu Deșert (Romania) was, and still is, at the centre of several restoration actions. The ARHAIC-Ambulance for Monuments Sălaj Association replaced the church's sheet metal roof with shingles (Monumentum Association, 2020). The Sălaj County Council contributed to the consolidation of the stone foundation, the replacement of the flooring, and the conservation and restoration of the interior painting (Monitorul de Sălaj, 2023).

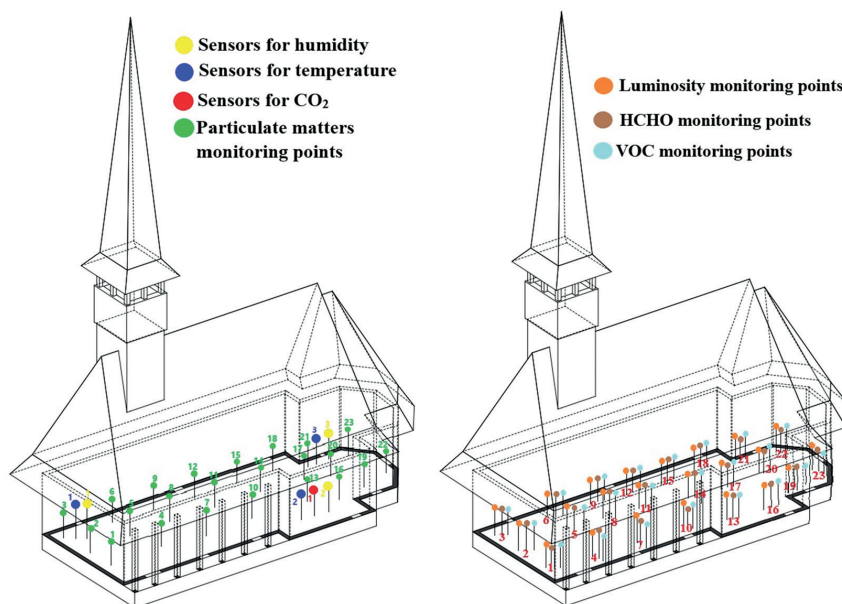
**Fig. 3** Spatial distribution of sensors and data collection points

Monitoring of indoor microclimate indicators of the wooden religious structure was carried out at different times of the day, depending on their nature (Ilies et al., 2022). Temperature, humidity and carbon dioxide were automatically monitored at an interval of 60 minutes, over a period of one year, using a BZ30 CO<sub>2</sub> air quality data logger sensor (Temperature, RH, CO<sub>2</sub>) and two BL30 climate data loggers (Temperature, RH). The accuracy of the sensors is indicated in Table 1. The sensors were positioned to cover the area of the church interior maximally, one BL 30 climate data logger sensor in the narthex and altar, and one BZ30 CO<sub>2</sub> air quality data logger sensor in the nave. The sensors were positioned at a height of 1.5m

(Fig. 3). Particulate matter (PM<sub>2.5</sub>, PM<sub>10</sub>), total volatile organic compounds (VOC), formaldehyde (HCHO) and natural light (NL) were recorded three times a day, in the morning (07:30), at noon (12:00) and in the evening (19:30), using 23 collection points (6 points in the pronaos, 12 in the nave and 5 in the altar; Fig. 3), covering the maximum area inside the wooden church. Sound level monitoring was done weekly, for two hours during services and a further three hours per week according to a specified schedule.

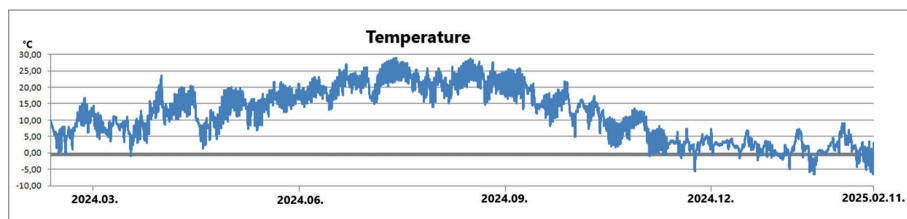
**Fig. 4** Indoor temperature fluctuations ( $^\circ\text{C}$ ) from February 12, 2024 to February 11, 2025

Because the wooden church did not have a heating and ventilation system, and some windows were damaged, the internal microclimate was closely conditioned by the external climate. The average temperature value during the study period was 11.67°C and did not correspond with the international ASHRAE standard. The thermal amplitude of the internal climate was large, with a value of 35.4°C. The maximum temperature value of 29°C was recorded on July 14, 2024, at 18:49, and the minimum value of  $-6.4^\circ\text{C}$  was recorded on two days in different months. The first recording was on January 16, 2025 at 07:21 and the second recording was on February 11, 2025 at 08:21.

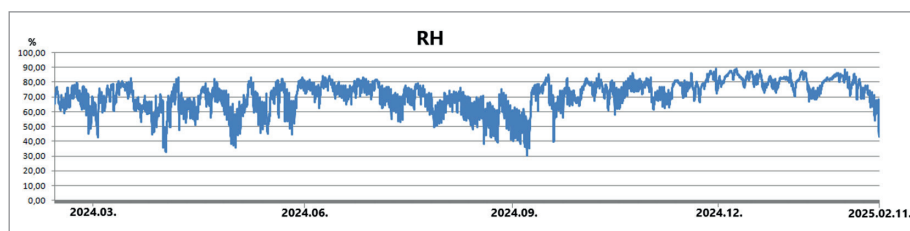
**Fig. 5** Indoor humidity fluctuations (%) from February 12, 2024 to February 11, 2025

The relative humidity inside the church had high values and presented an average value, during the study period, of 70.83%, with a maximum value of 89.20% recorded on December 10, 2024 at 2:52 PM and a minimum value of 30.10% recorded on September 8, 2024, at 7:19 PM.

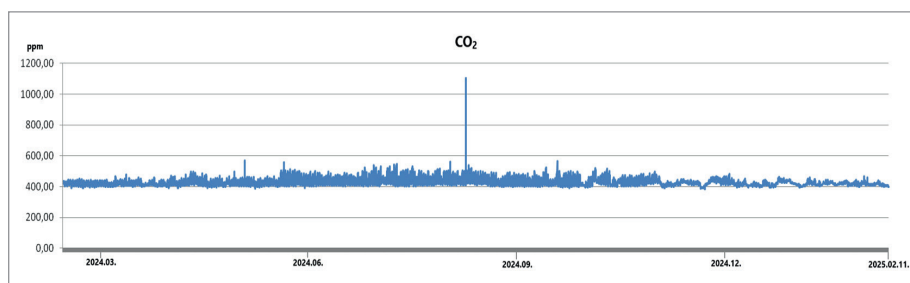
**Fig. 6** Indoor CO<sub>2</sub> fluctuations (ppm) from February 12, 2024 to February 11, 2025

The interior microclimate of the church was conditioned by the exterior microclimate. The periods with the maximum and minimum values of the interior temperature align with the periods of the exterior climate, and the closeness between the average temperature values during the study period can be noted—interior  $11.67^\circ$  and exterior  $11.8^\circ\text{C}$ . In terms of the relative humidity, the average value inside the wooden church (70.83%) was influenced by the exterior climate (72.44%), and the close average values of the relative humidity are notable. During the study period, the average value of the CO<sub>2</sub> concentration was 429.18 ppm, with a maximum value of 1103 ppm recorded on August 8, 2024, at 8:00 PM and corresponding to the time of the religious service for the church's patron saint. The minimum value was 384 recorded on November 22, 2024, at 10:53 AM. The CO<sub>2</sub> concentration values mostly varied between 400-500 ppm, while periods with values higher than 1100 ppm were recorded during religious services, due to the large number of parishioners and the oppressive air. The access path (door) remained open, influencing the value of the CO<sub>2</sub> concentration, and contributing to the reduction of the values.

The analysis of the CO<sub>2</sub> concentration in the monitored wooden church fell within the standards of the ASHRAE position document on indoor carbon dioxide, American Society of Heating and ANSI/ASHRAE Standard 62.1-2010, Ventilation for acceptable indoor air quality, which provides for a concentration < 1000 ppm.

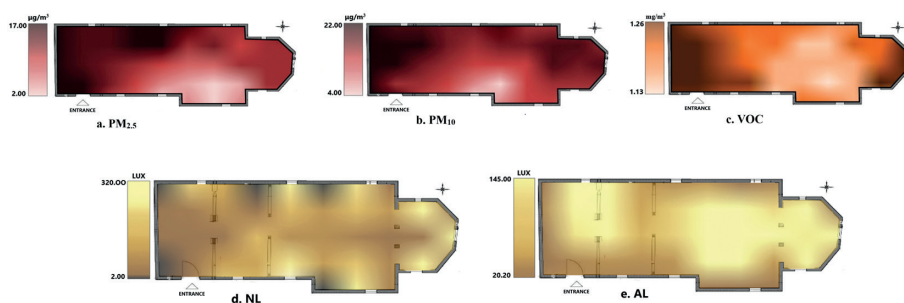
**Fig. 7** Indoor average values of PM2.5, PM10, HCHO, VOC, NL and AL for each monitoring point - (a) Particulate matter PM2.5, (b) Particulate matter PM10, (c) Volatile organic compounds VOC, (d) Natural light, (e) Artificial light

The PM<sub>2.5</sub> concentration values fluctuated inside the church, ranging from the lowest at 0.00  $\mu\text{g}/\text{m}^3$ , with the maximum reaching as high as 24.00  $\mu\text{g}/\text{m}^3$ . The higher values occurred in the more closed spaces. During various activities in the church, the PM<sub>2.5</sub> level increased due to the existing carpets and textiles, as well as the presence of dust that accumulated inside and penetrated from the outside through the damaged and degraded windows. As can be seen in Figure 7a, in the spatial distribution of the average PM<sub>2.5</sub> values, higher values were found in the narthex (at the entrance to the church) and in the altar, and the lowest values were in the nave.

For PM<sub>10</sub>, the values fluctuated within the church, ranging from lows of 0.00  $\mu\text{g}/\text{m}^3$  to highs of 29.00  $\mu\text{g}/\text{m}^3$ . The spatial distribution of PM<sub>10</sub> followed the PM<sub>2.5</sub> pattern, with higher values in the narthex and altar, and lower values in the nave. PM<sub>10</sub> concentration values were influenced by textiles, damaged windows and reduced dust removal.

of between 2 and 320 lux, with lower values in the narthex and at the joints of the structure. The extreme values of natural light were between 0 and 490 lux, influenced by the external environment, where natural light values on sunny days reached a maximum of approximately 147,000 lux. Artificial light was closely linked to the lighting fixtures, and inside the church, there were 3 lighting sources—the first in the narthex, the second in the nave (candelabra) and the last in the altar. The values of artificial light fluctuated between 20.2 and 145 lux. The highest values of artificial light were in the area close to the coverage of the lighting fixtures, as seen in Figure 7e.

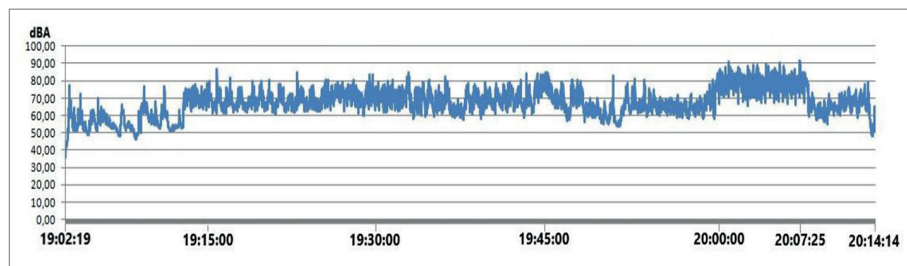
**Fig. 8** Acoustic intensity level during the religious service on 08.08.2024, in the time interval 19:02:19 - 20:14:14

19:02:19 at the beginning of the service and a maximum value of 91.4 dBA recorded at 20:07:25. Higher values may cause discomfort to the human body.

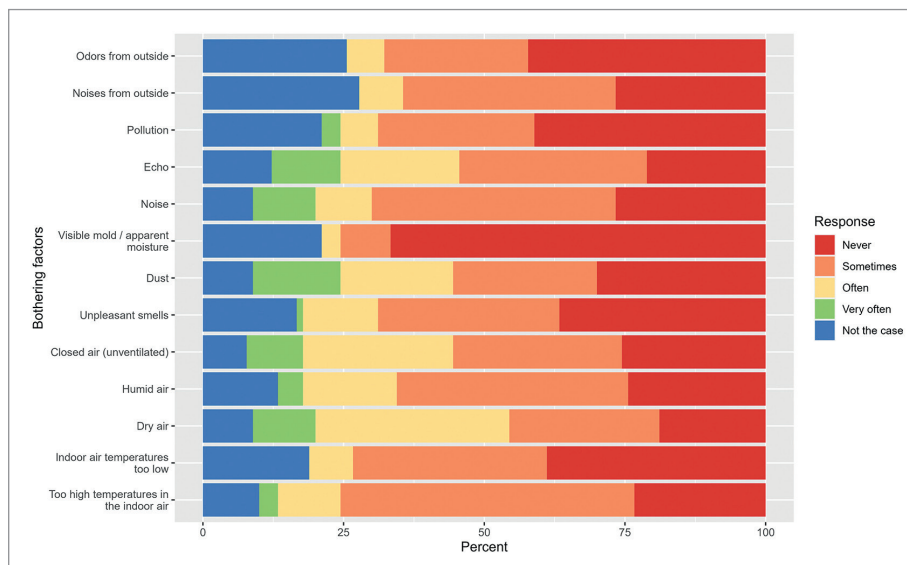
**Fig. 9** The identified bothering factors in the church interior

In the evaluation of factors that participants found bothersome within the space, the top three issues reported "often" or "very often" were dry air (45.5%), closed or unventilated air (36.7%), and dust (35.6%). These factors were the most frequently cited as causes of discomfort in the space. Conversely, the least reported issues included visible mould or apparent moisture (3.3%), odours from outside (6.7%), and indoor air temperatures that were too low (7.8%), indicating minimal concern regarding these factors among participants (Figure 9).

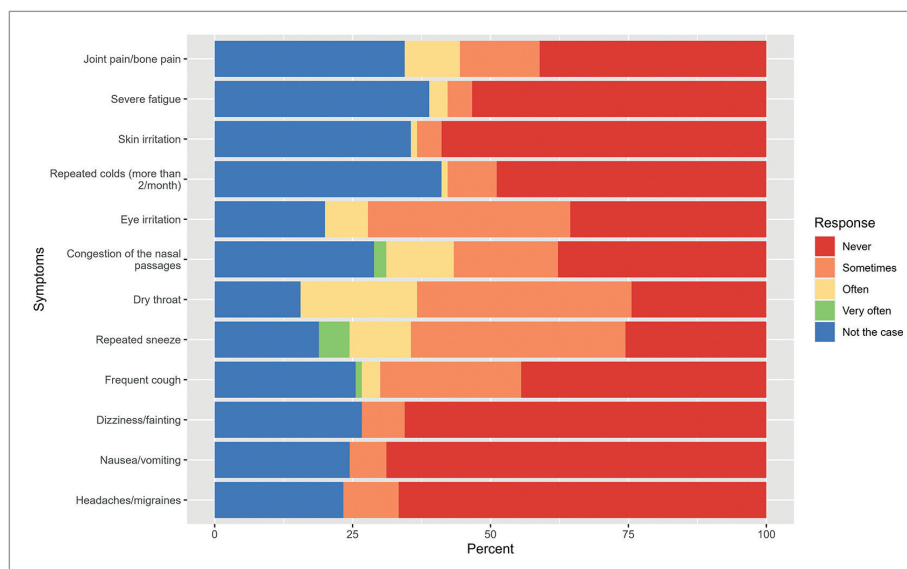
**Fig. 10** The most frequently reported symptoms occurring in respondents during a visit to a church interior

The most frequently reported symptoms experienced “often” or “very often” were dry throat (21.1%), repeated sneezing (16.7%), and congestion of the nasal passages (14.4%). Conversely, the least reported symptoms were nausea or vomiting, dizziness or fainting, and headache and migraine.

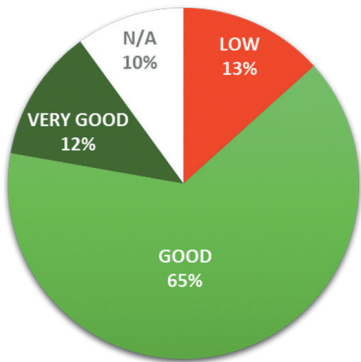
**Fig. 11** Perceived indoor air quality according to respondents

Participants reported spending an average of 1.2 hours per day in the space, with religious activities being the primary reason for visitation (63.3%). The majority rated the air quality within the space as “Good” (64.4%), while a small portion rated it as “Low” (13.3%, see Figure 3). In cases where air quality issues were observed, 22.2% noted that they were most prominent at the end of activities. Most participants (72.2%) indicated that symptoms related to air quality resolved within 1-2 hours after leaving the space, and only 4.4% were aware of any complaints about the space’s air quality. Among participants aware of complaints related to the space (n=4), reports of inconvenience were equally attributed to occasional visitors or users (50.0%) and individuals from the neighbourhood (50.0%). When describing the ideal environment, participants emphasized emotional and spiritual benefits, with equal mentions (25.0% each) of finding peace through prayer, experiencing a beautiful and recommended location, achieving personal peace in a relationship with God, and feeling an intensified divine presence that strengthens religious convictions (see Table 3).
